Exhibit C

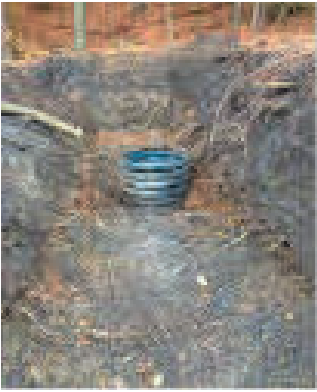
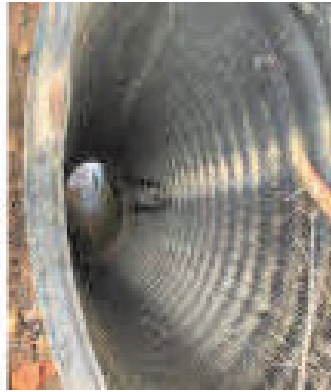
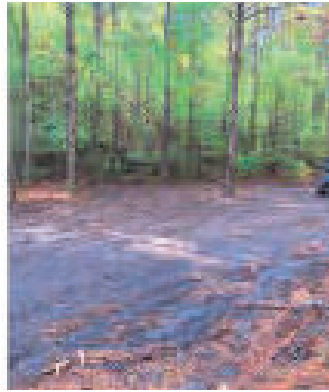
Installing Calcitic Limestone Rip-Rap, Rip-Rap Calcitic Lined South OLC3

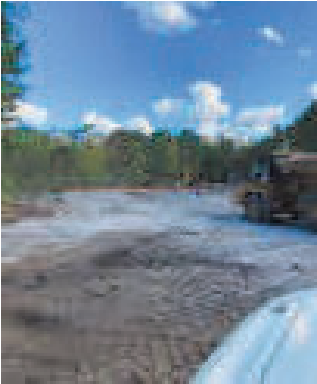
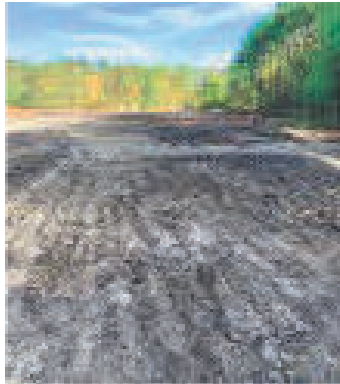
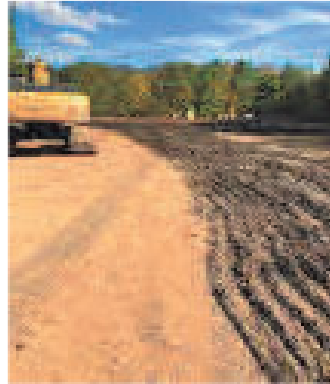
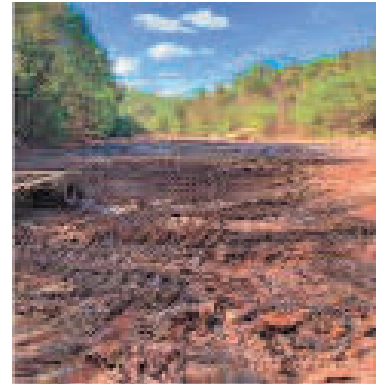
Installed Test Water Pit Pipe, Reclaimed Water Test Pit Site

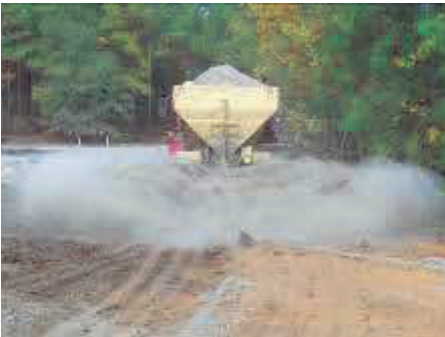
Spreading of Limestone, Factory Manure, and Brewer's Mash with light surface mixing

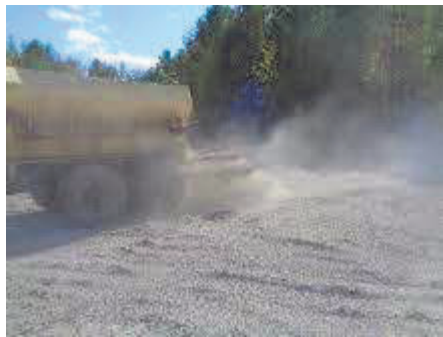
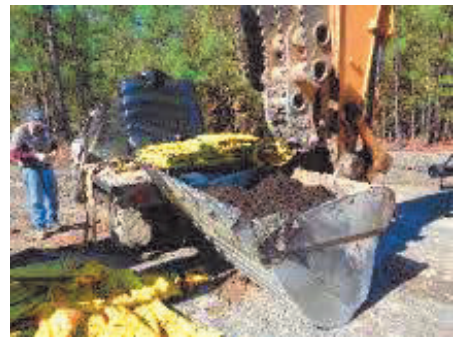
More pictures of Liming

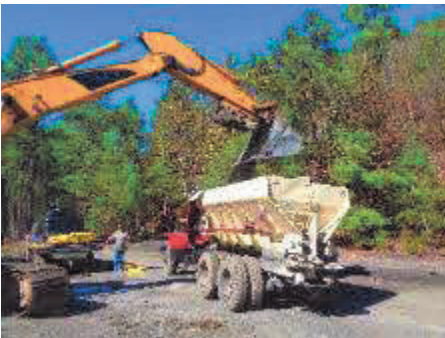
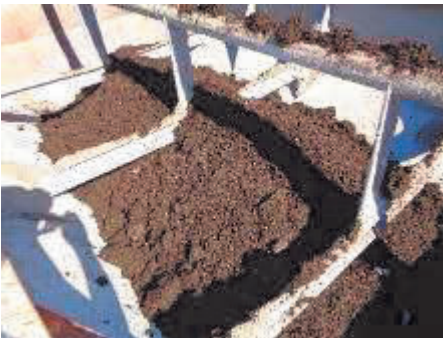
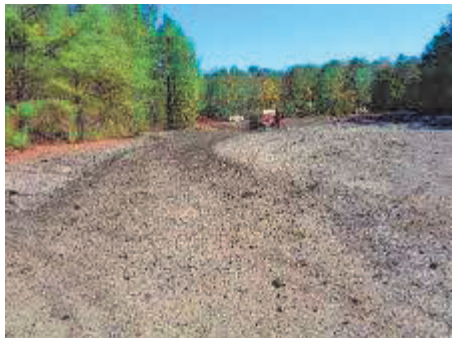
More Pictures of Manure

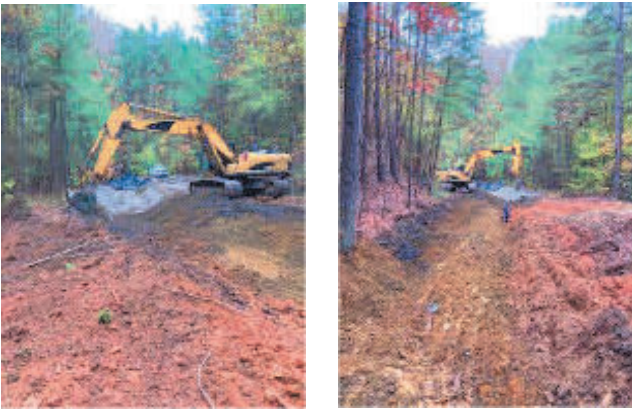
Digging and Installing the Open Lined Channel (OLC4) from the SEEP 5 in the most northwestern gullies

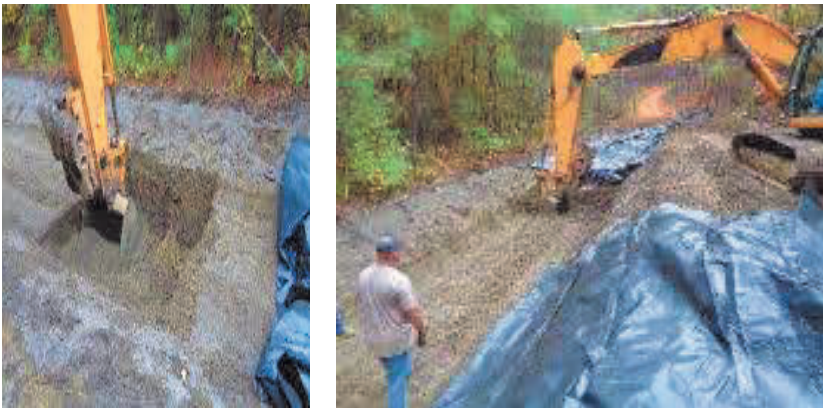
Digging Bio-Reactive Treatment Sump in OLC4

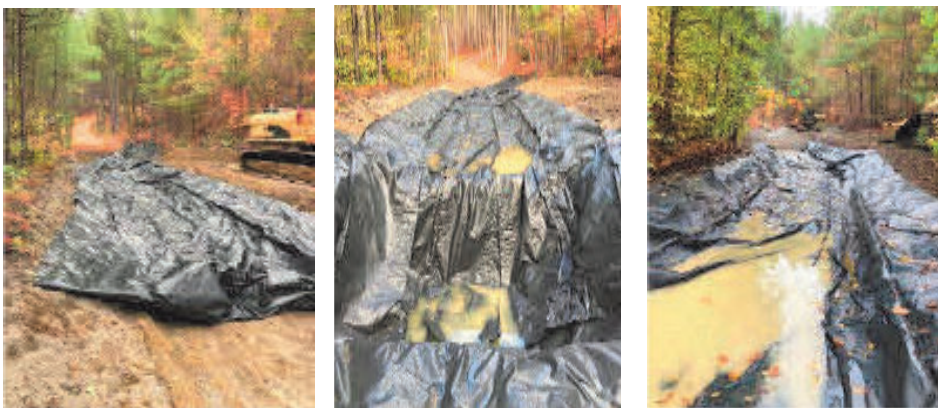
Installing an impervious liner in OLC4

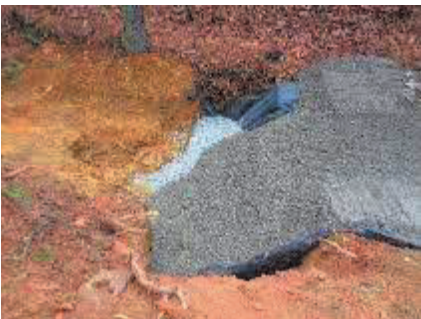
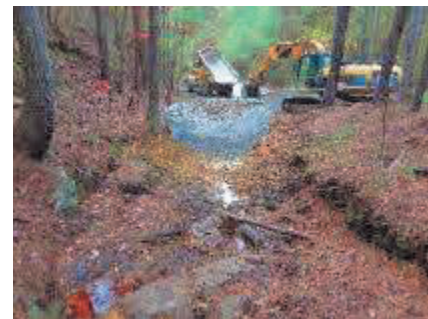
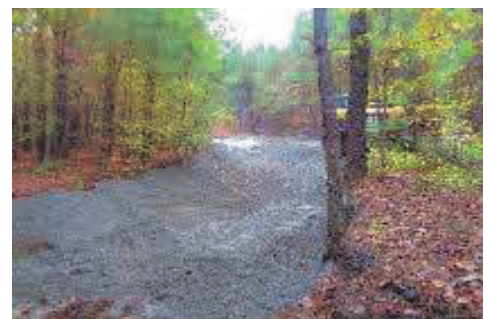
Digging and Installing a Cutoff Trench with bentonite in the OLC4 at SEEP discharge location

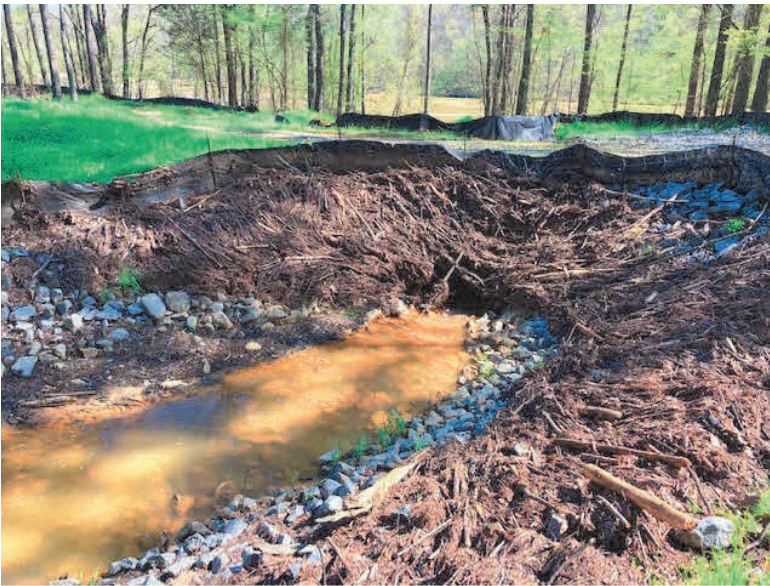
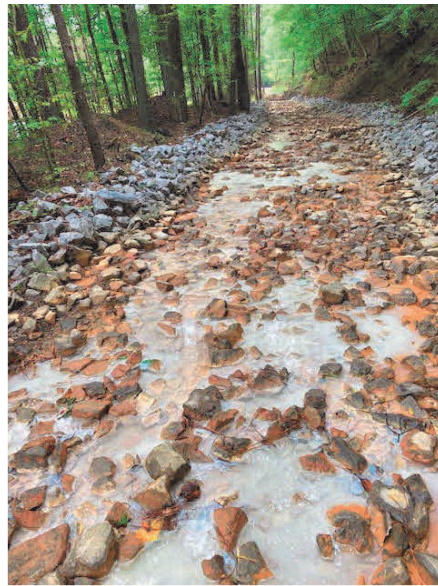
Weirs installed at Seep 3 along the river at the spillway approximately 12inches above river elevation
Monitoring of Seep 3 Discharge Rates after infiltration flows have been cut-off with OLC drainage courses and Clay

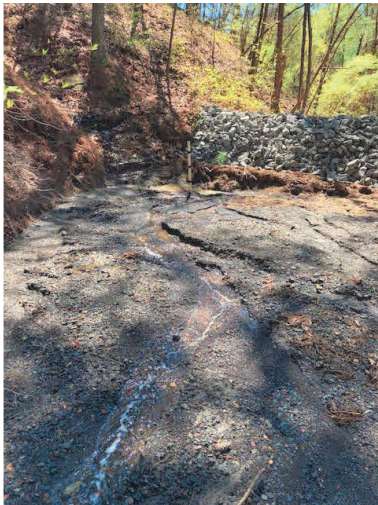
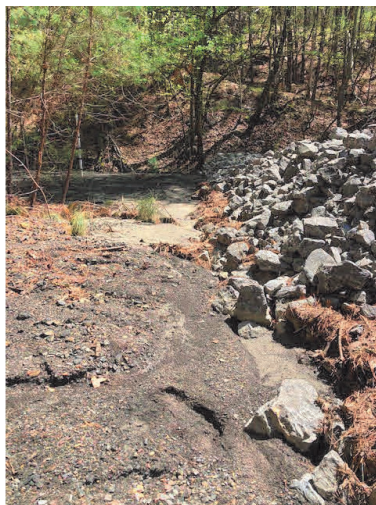
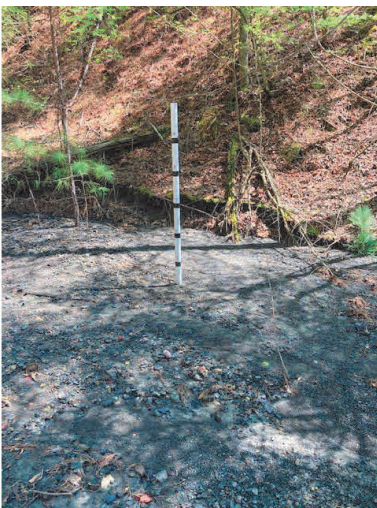
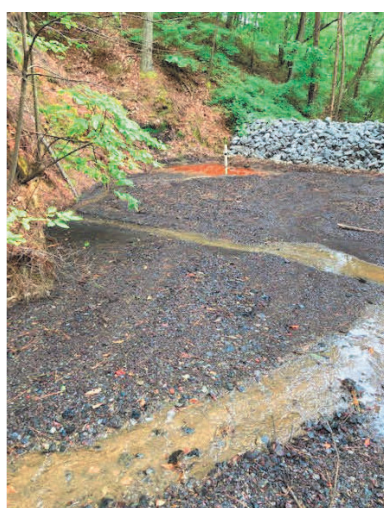
OLC3 Functioning Well. Water clarity is very good. Iron stain indicates alkaline material is functioning.
